Mayne Tree Expert Company, Inc.

November 30, 2009

RE: 220 FELTON DRIVE, MENLO PARK

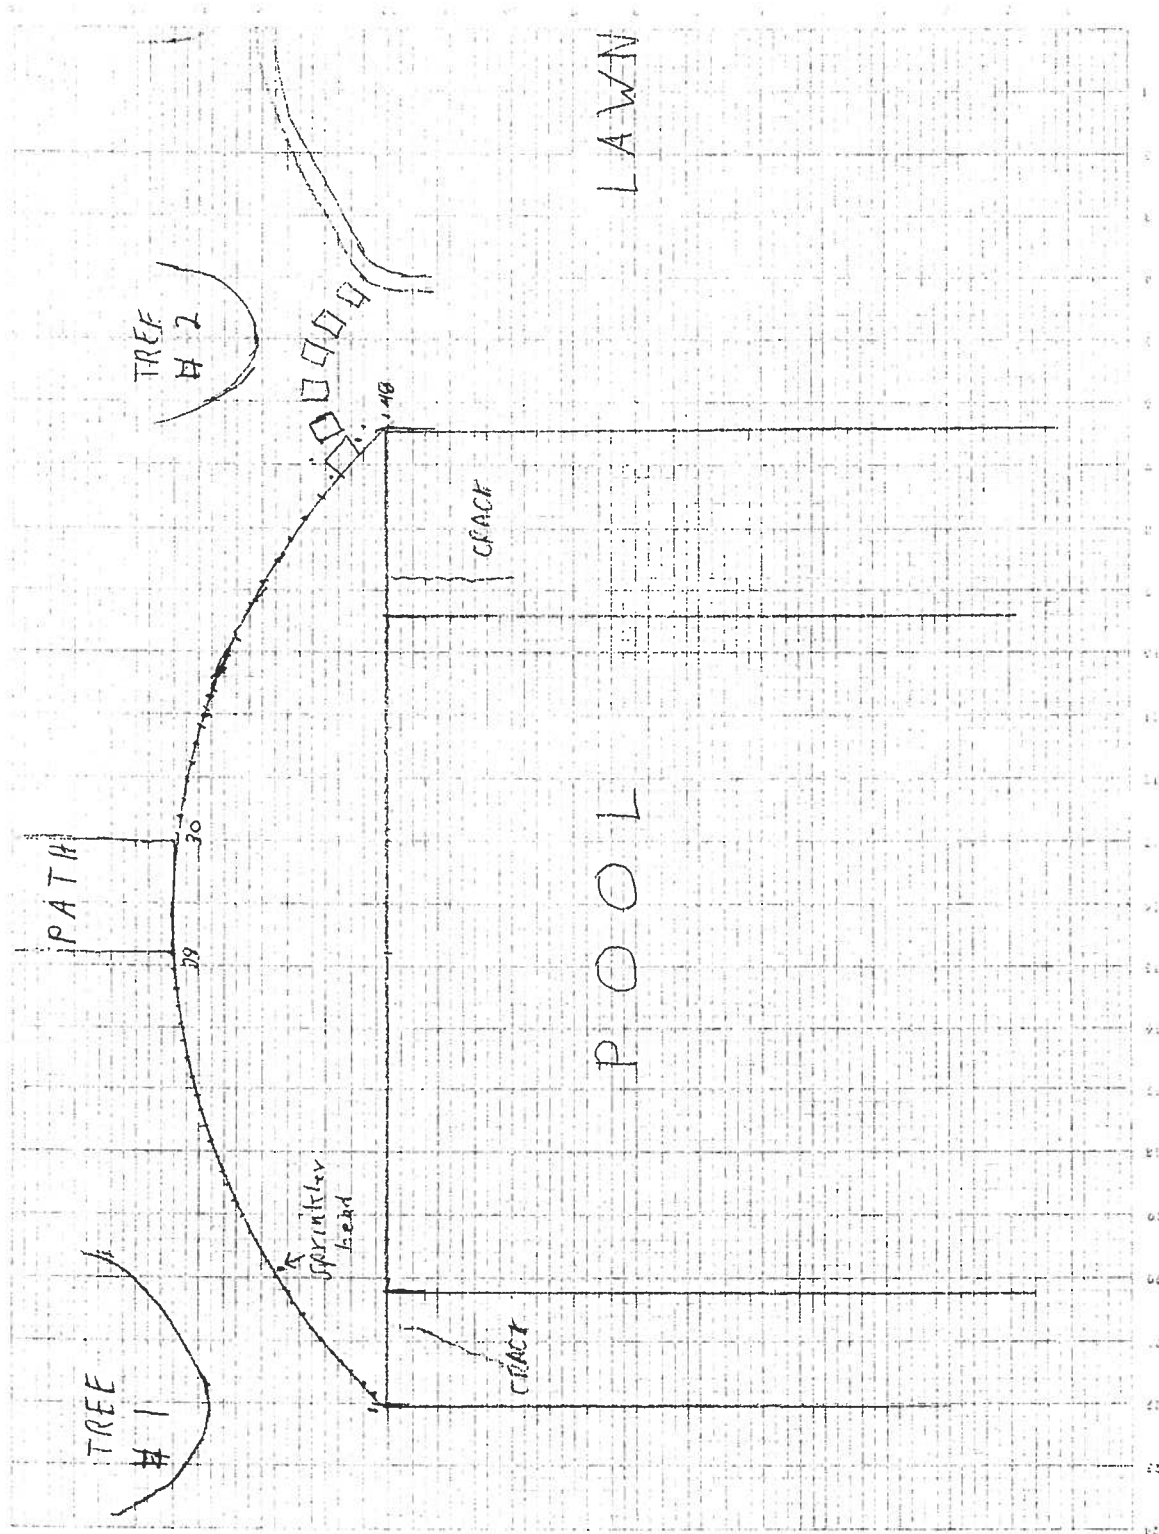
I have completed the root probing. The purpose was to explore the soil along the curved concrete pad at the easterly end of the pool (see diagram). This end of the pool is being uplifted and cracked, as is the concrete path along the lawn and patio. The pool cover housing and mechanism has been dislodged and broken.

I used a slap hammer-type 47-inch steel rod and probed down every six inches along the concrete pad (see diagram). The rod was pounded down its full length or until it hit a root. Each depth was noted, along with any pertinent information.

Due to expected root loss, I recommend removal of the three trees addressed in this report. The potential damage to the new house at 218 Felton Drive is too great to allow retention of the trees.
